**A Historical and Architectural Study of
Three Rustic Structures at Giant Forest in Sequoia National Park
The Market, District Ranger's Residence, and Comfort Station**

Prepared by
C. Craig Frazier and Craig A. Kenkel
Historical Architects

**HISTORIC STRUCTURES REPORT
SEQUOIA NATIONAL PARK**

Approved
December 7, 1988

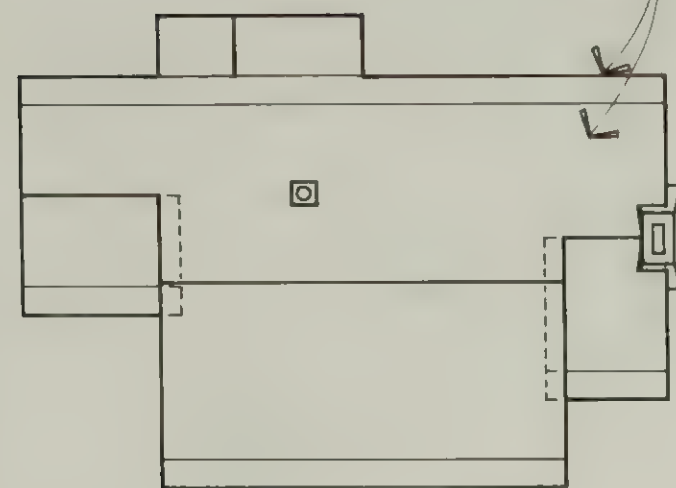
WOOD SHINGLE ROOF AND SHEET METAL SNOW FLASHING IS AGED AND EXPECTED TO FAIL BY 1991

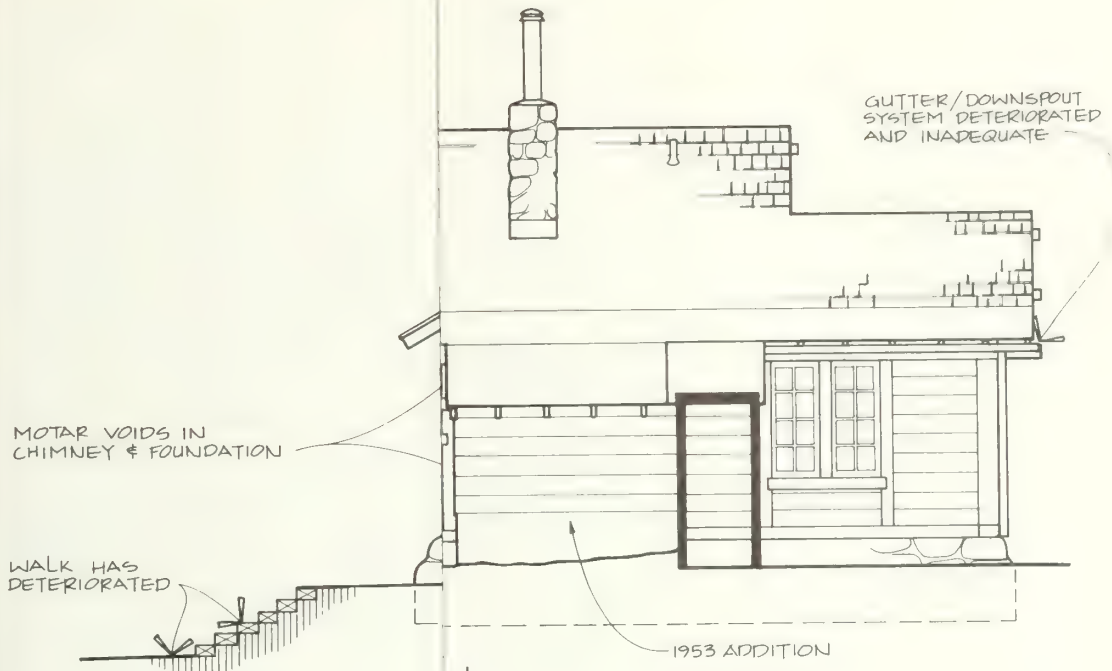
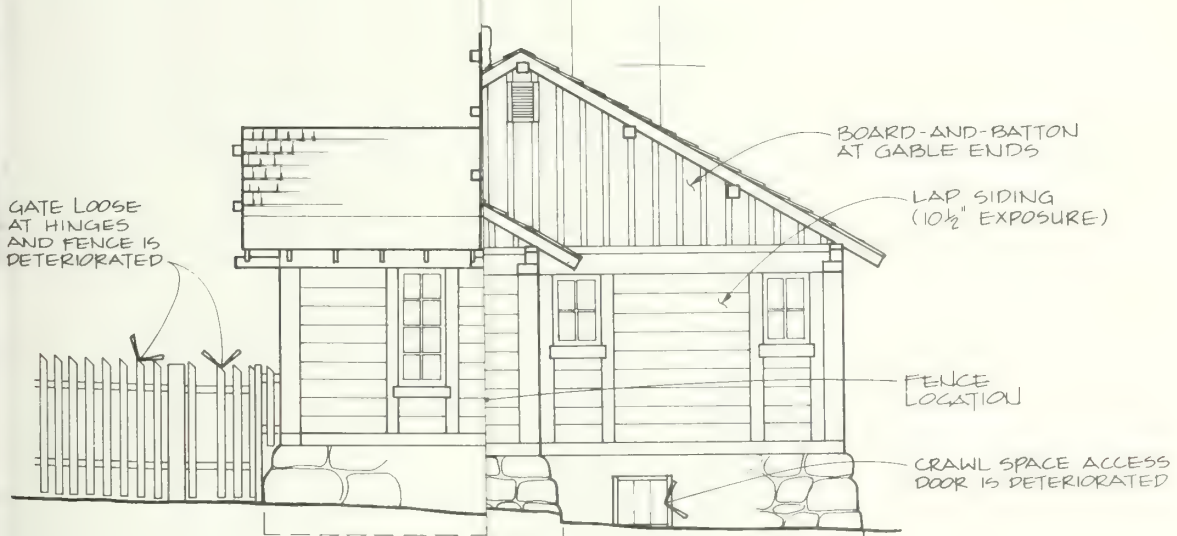
DESIGNED C FRAZIER C KENKEL	SUB SHEET NO.	TITLE OF SHEET RANGER RESIDENCE ELEVATIONS DEFICIENCIES	DRAWING NO. 102 25,001	
DRAWN C KENKEL			PKG NO.	SHEET 12
TECH. REVIEW G HIGGINS				OF 12
DATE 12/87

TITLE OF SHEET
RANGER RESIDENCE
PLANS & DETAIL
DEFICIENCIES

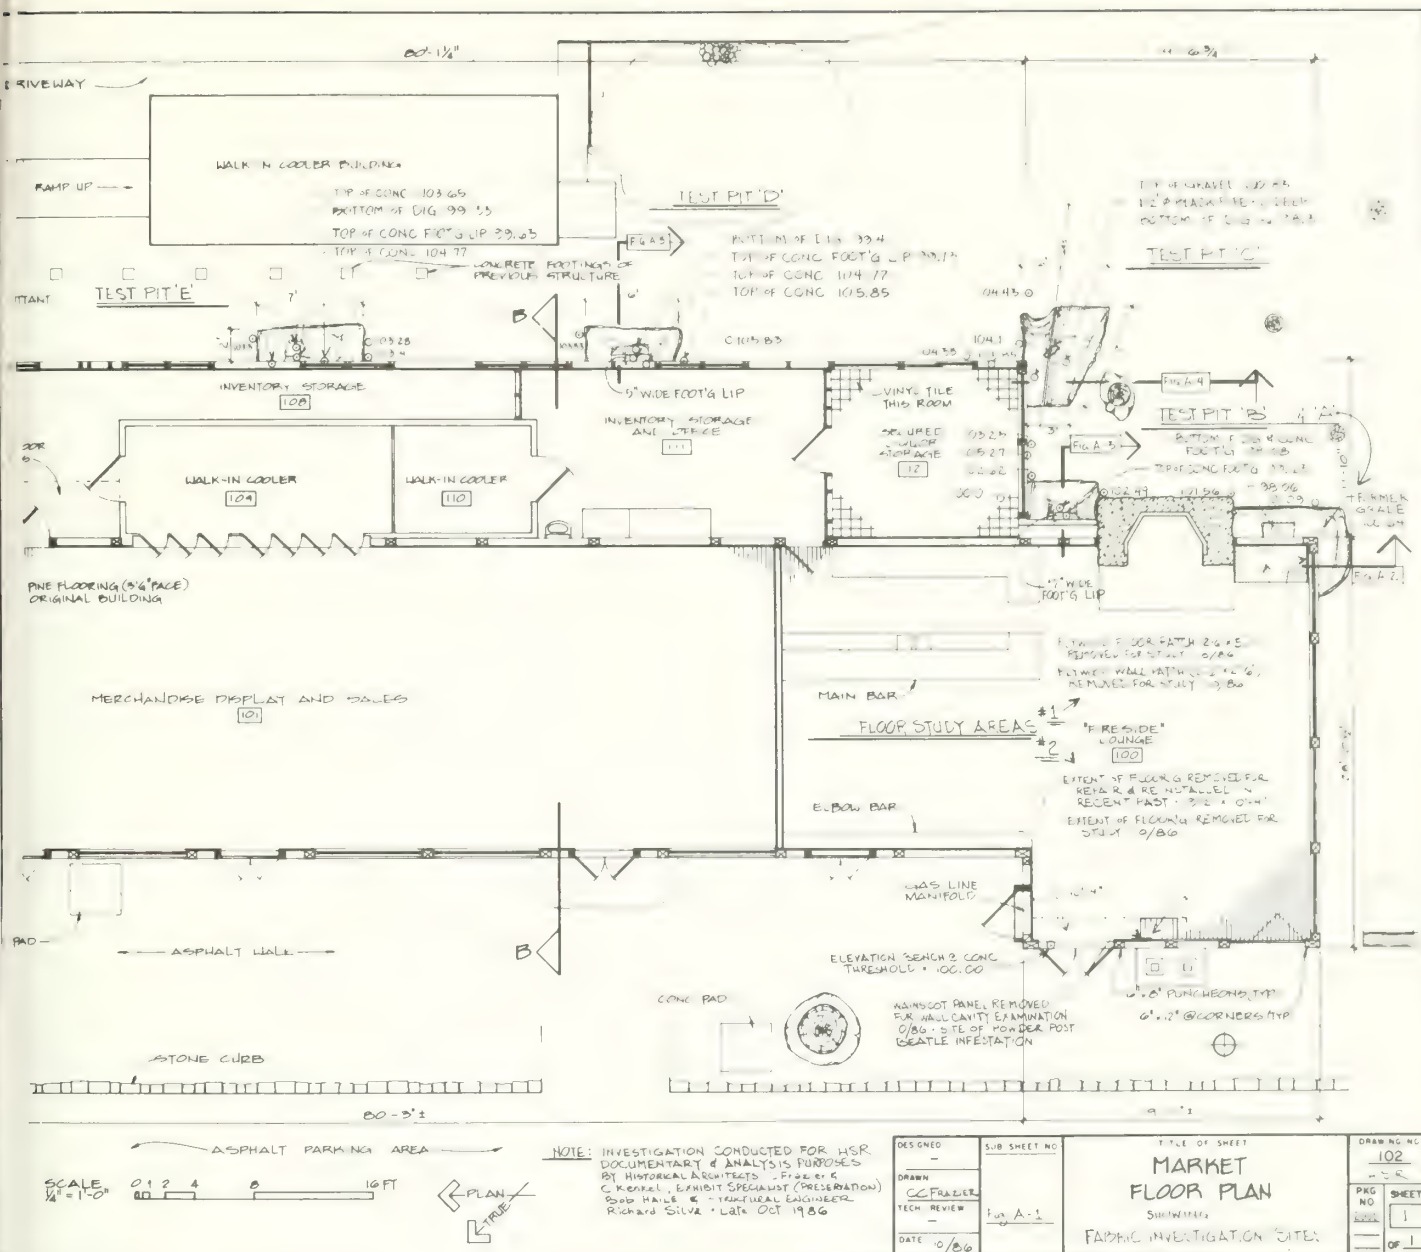
Figure A-1. Drawing--Market Plan Showing Fabric Investigation Sites
(10/86)

Finally, moisture barriers are recommended for both the floor of the crawl space and wall systems. The roofing felt system in the market walls is not entirely effective--it needs to be replaced.

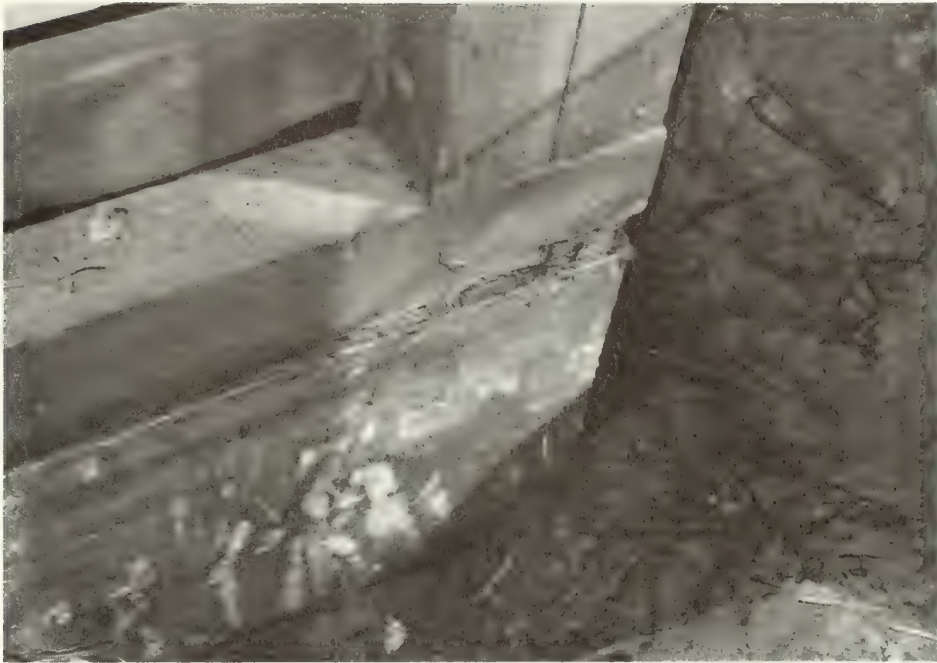
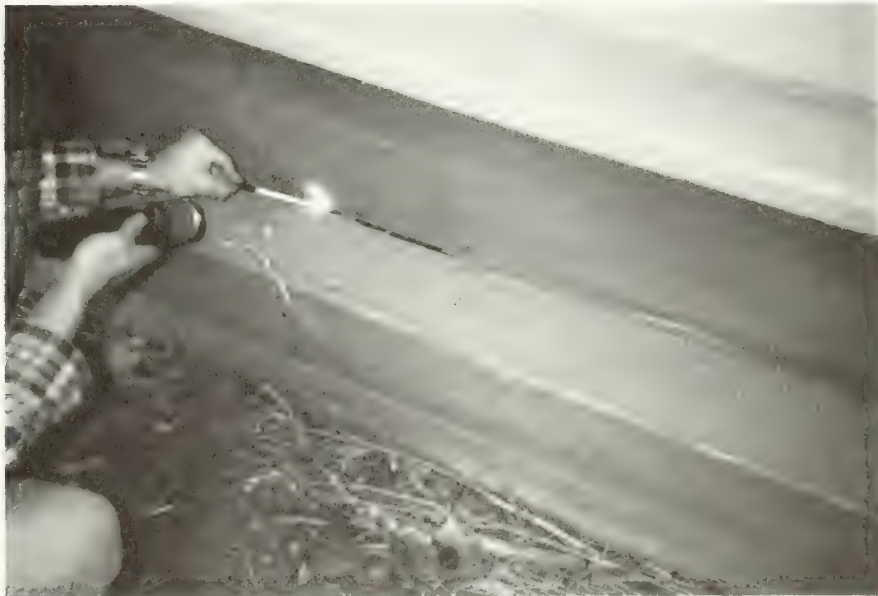
Figures A-8 and A-9. Market at southeast corner, test pit A (10/86). The upper view shows the extent of the exploratory excavation. The hole goes down 28" below top of concrete (below sill beam) and extends from the southeast corner to the chimney. At right, the sill beam is rotted away as is clearer in the lower photograph. The plywood patch replaces several pieces of shiplap siding which rotted away and have been removed. The lower photograph also shows that the bottom of the corner puncheon has begun to be attacked by rot.

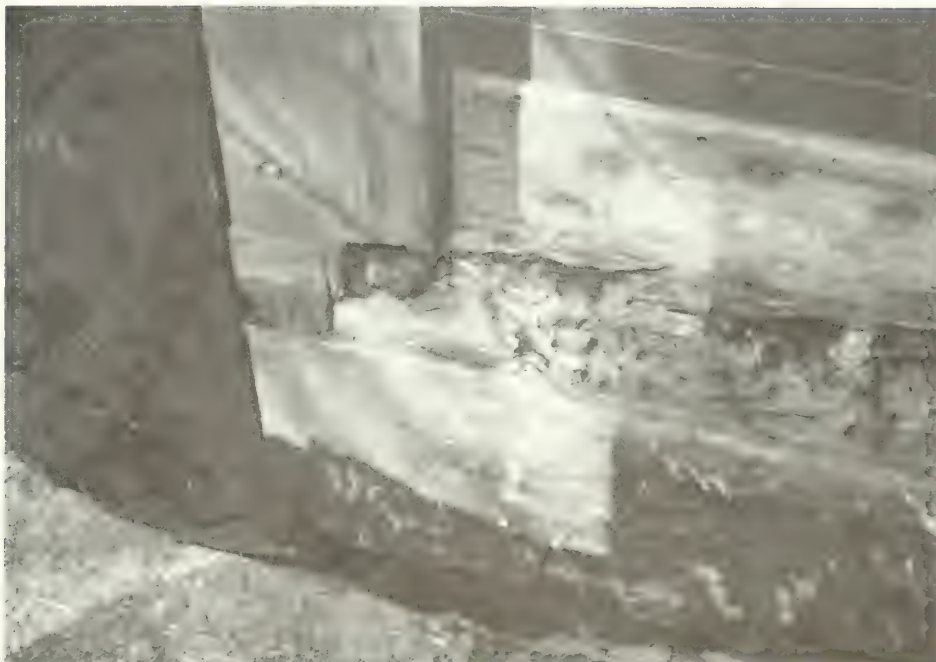
Figure A-10. Market, test pits B and C (10/86). The upper view shows the extent of excavation at the juncture between the east wall of the market, the 1930 chimney, at left, and the 1938 addition retaining wall, at right. At a depth of 5 feet was found the concrete footing, detail at bottom left. The photograph at bottom right shows test pit C at the southeast corner of the 1938 addition (with B at the upper right corner in the far ground). The addition wall is battered slightly to function as a retaining wall. It also was coated with a moisture barrier, but this is no longer effective. the 1½-inch gas line, visible in both test pits, comes from the main manifold on the west side of the market, up through the market attic and exits at this location where it goes to another building--it does not serve the market.

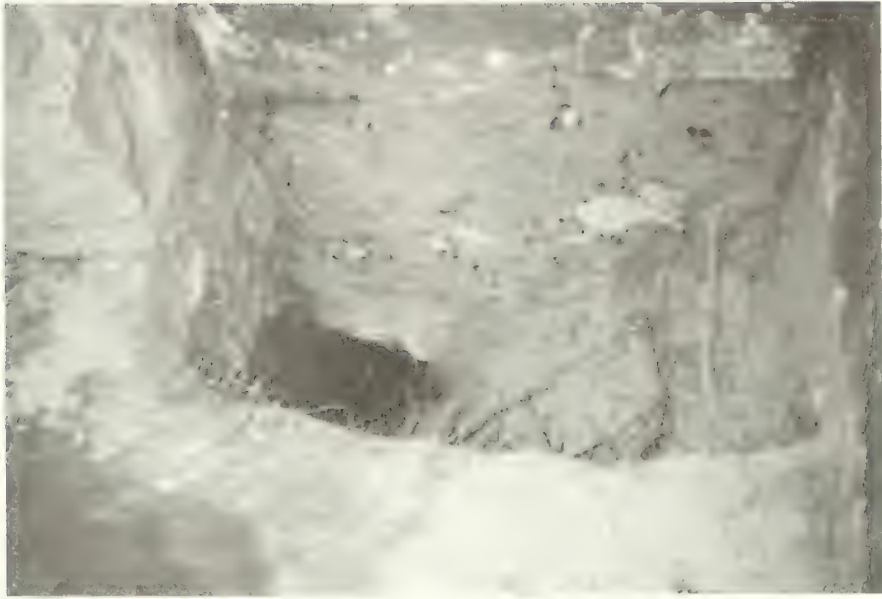
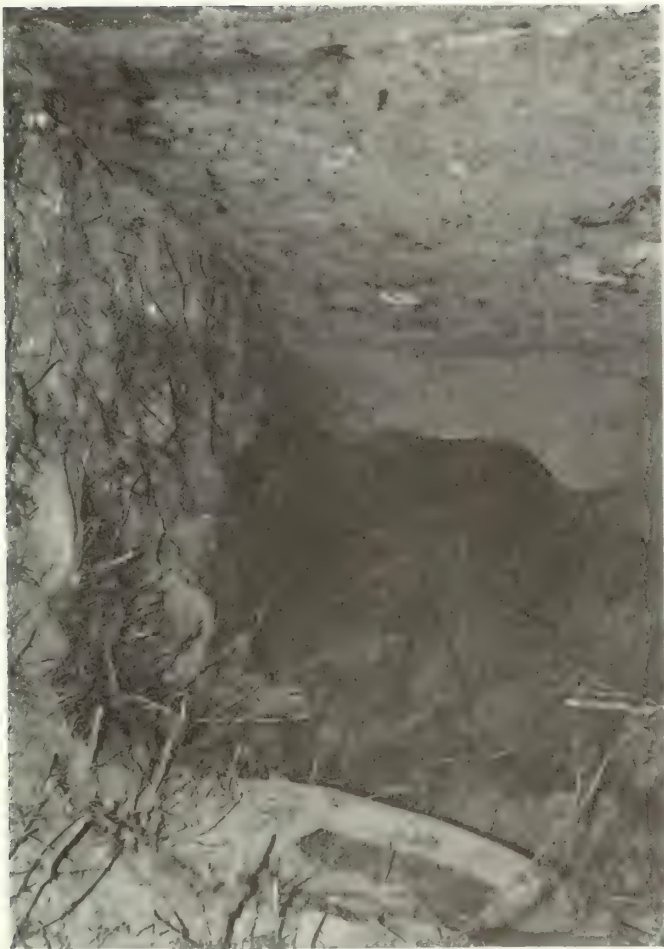
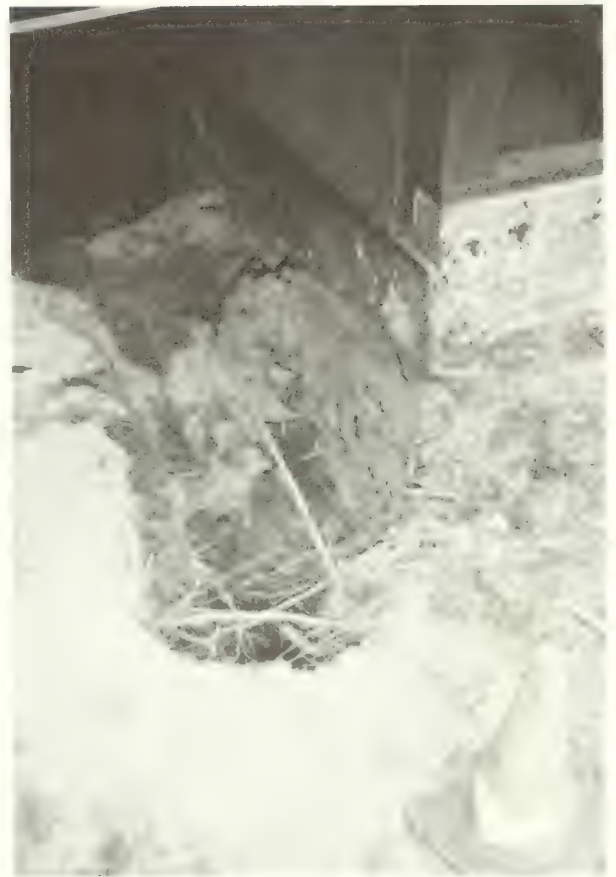
Figure A-11. Market, Test Pits D and E (10/86). These views show the extent of excavations along the east (rear) wall of the 1938 addition. Both of these holes are about 5-feet deep, both revealed the lip of the wall footing, confirmed the batter of the wall and its condition. The bitumin waterproof coating is consistently ineffective. Also, both pits included the 6-to-8-inch thick gravel drainage lense which helps establish the original grade and the depth of the proposed drainage excavation along the rear of the building.

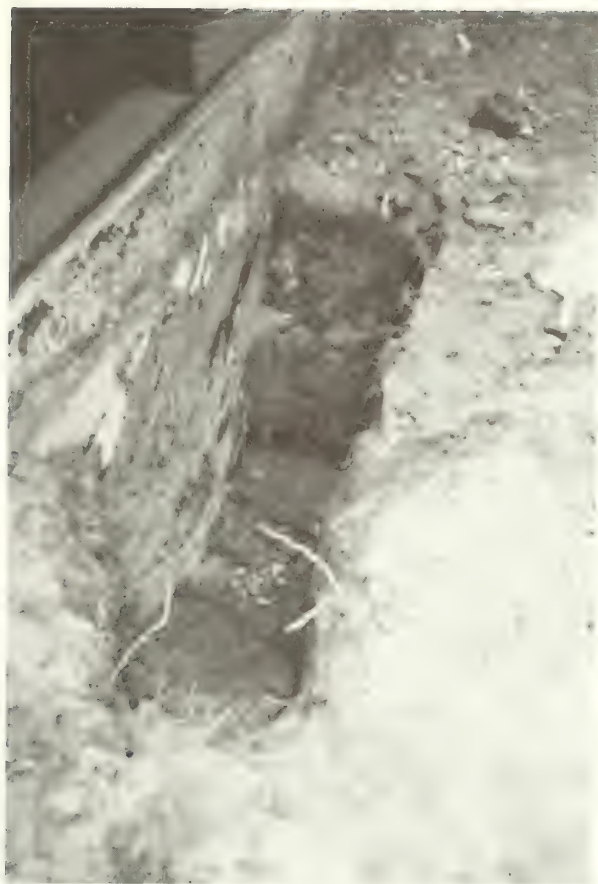
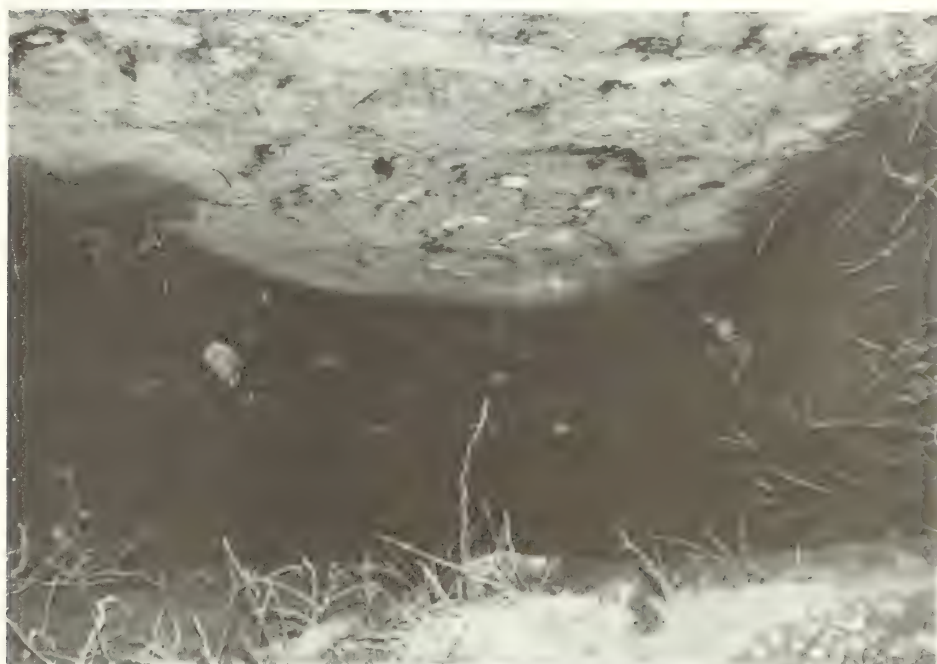
Figure A-12. Market Interior Fabric Investigation at Southeast, Room 100 (10/86). Plywood patches, part of a repair job of the 1970s or early 1980s, were removed from both floor and wall at this corner adjacent to the fireplace. The repair was done to replace rotted material, but did not address the cause of the rot--excessive moisture. Besides rotted joists, subfloor, beams and wall paneling, also revealed by this exploration was the shallowness of the crawl space and the fact that several crawl space ventilation windows are entirely blocked by exterior soil build-up.

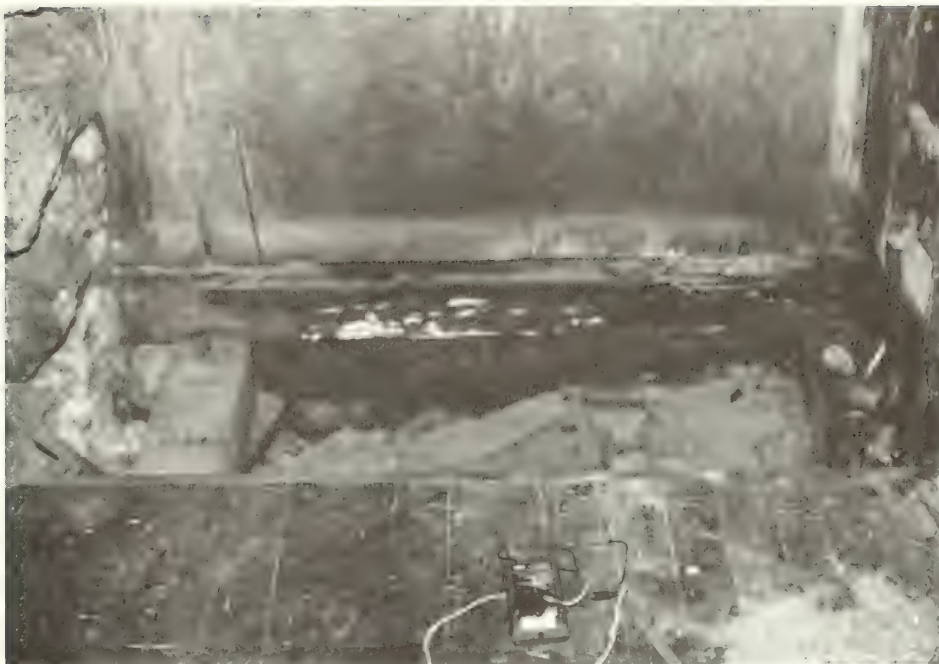
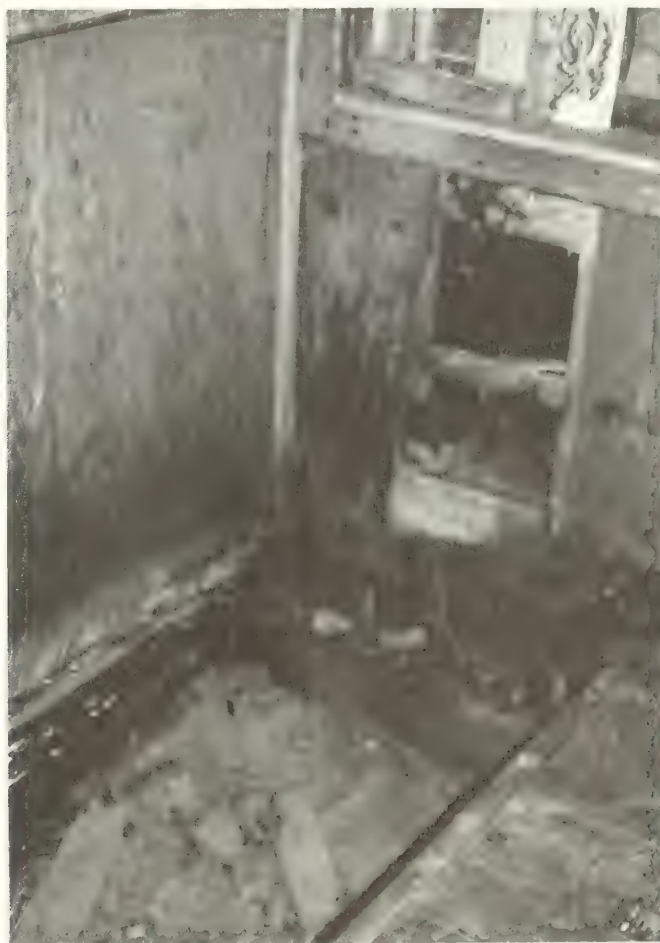
Figures A-13 and A-14. Market Crawl Space (5/86 and 10/86). The upper view shows the crawlspace as seen below the north end of the market where there is about 30 inches between the earth floor and the wooden subflooring. The lower view shows one of the 5 x 7 (6½" x 4-3/4" typically) floor beams vertically in contact with the earth. The end joist in the lower view is severely rotted and instrument readings indicated nearly 30% moisture content. Some of the crawl space earth should be excavated at the south end, several structural members must be replaced and the crawl space ventilation system needs to be improved.

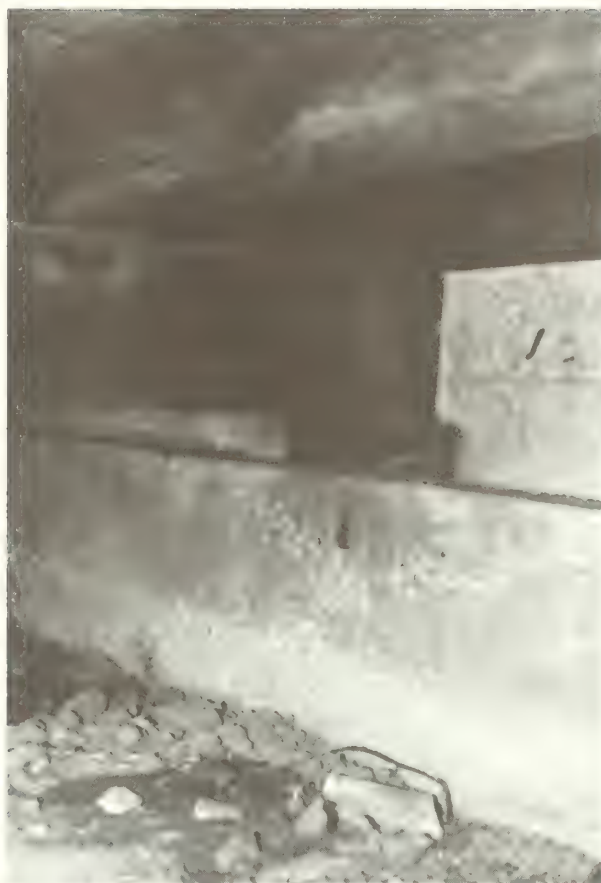
Figures A-15 and A-16. Market Crawl Space Vents (10/86). The above view is from inside the crawl space at the south end of the market (below room 100). This vent window is entirely blocked by earth on the exterior and partially obscured by debris and floor joist on the interior. The lower view is from the exterior of a vent on the market west wall. Most vents are reduced in effective size by the floor structural system, so it is especially important to eliminate additional, avoidable blockages. Also of note in the upper photograph is the decayed and fractured joist and beam, the result of excessive moisture and lack of adequate ventilation.

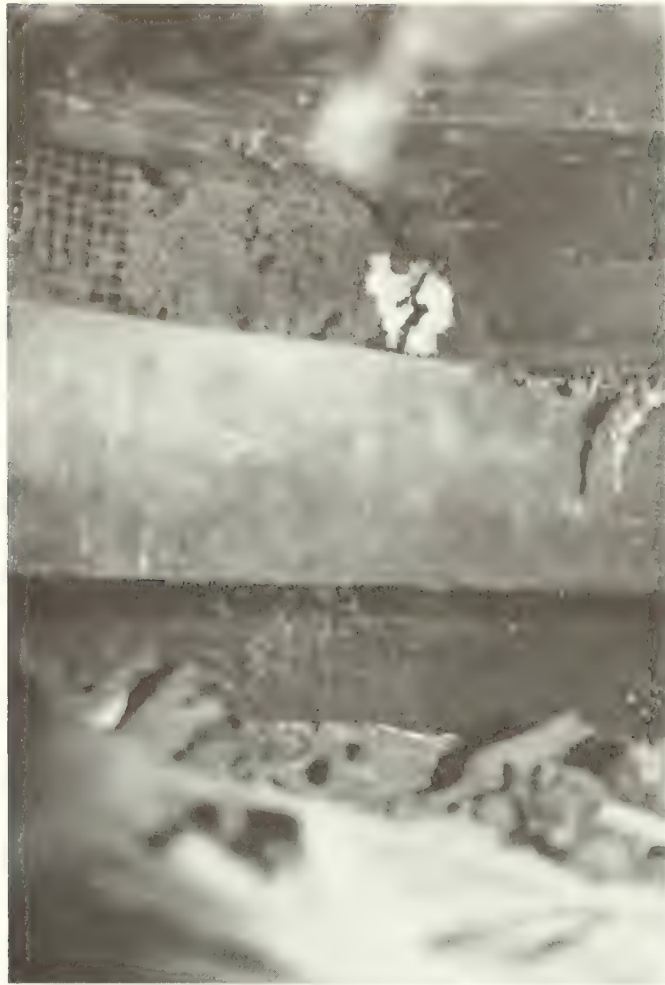
Figure A-17. Market Interior Fabric Investigation, West Side of Room 100 (10/86). A 27 x 19 inch section of flooring, which had been previously removed as part of a repair effort in the late 1970s or early 1980s, was taken up to reveal the nature of the "repair" and determine the extent of suspected deficiencies. Part of a joist and some subflooring had been replaced in the repair effort. Additional joists and subfloor are in need of similar treatment because of their advanced state of rot. The 1 x 4 base and a single wanescot panel were removed to reveal the cause of the deterioration. As in the investigation at the southeast corner, excessive moisture is the culprit--the crawl space is shallow, the vent window at this location is buried by the asphalt sidewalk outside, and the asphalt is used as a moisture barrier but traps moisture against the adjacent door threshold. See also next figure.

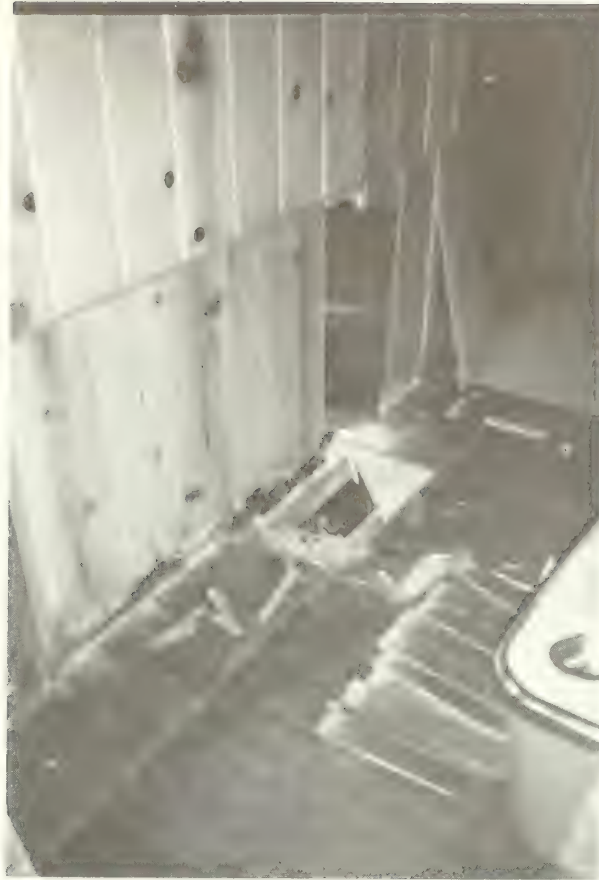
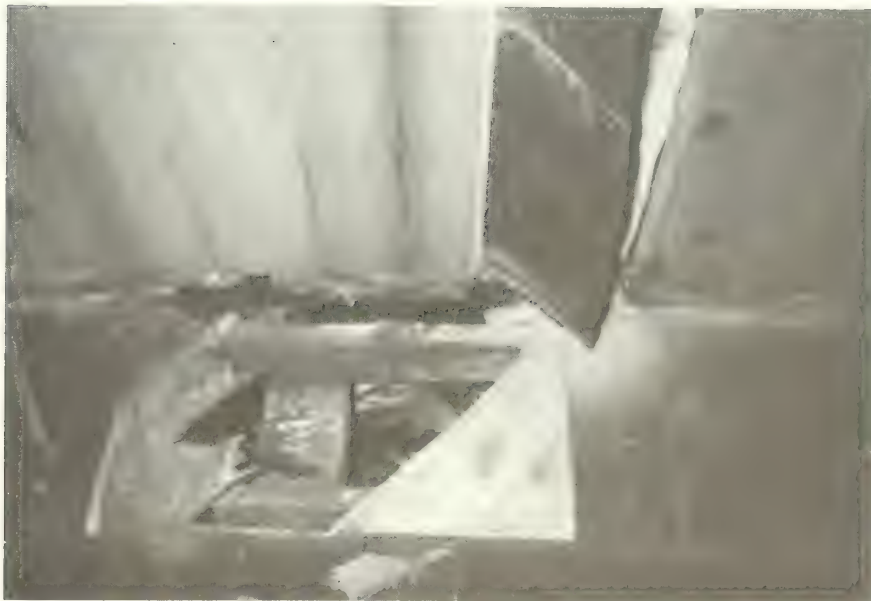
Figure A-18. Market Interior Investigation at West Wall of Room 100 (10/86). These views show the wall cavity within the wainscot adjacent to the area of flooring taken up. Roofing felt was employed by the builders on the inside face of the exterior shiplap siding and on the interior side of the wall panel nailers. The cavity between was found to be full of frass from wood boring insects. An examination of the frass revealed living larval-stage insects, i.e., an active infestation is present. An examination of the exterior side of the wall revealed locations of beetle egress at the ineptly painted underside of horizontal puncheon members.

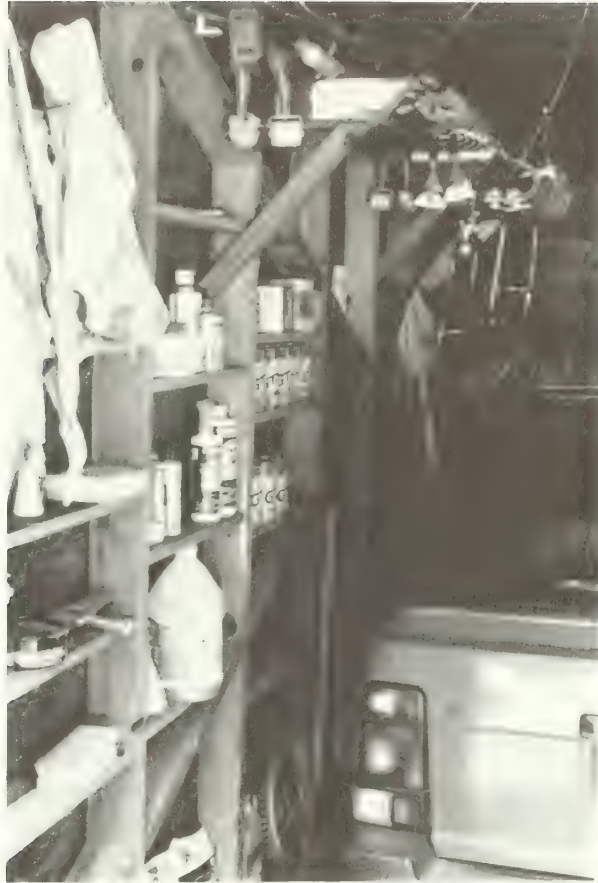
Figure B-1. Ranger Residence Garage Wall Framing and Diagonal Bracing

The ranger residence and garage foundation, floor system, walls and roof structure were all found to be in good condition (see figures B-1 & B-2). There was no evidence of cracks, permanent deflections, joint failure or displacement, connection breakdown, etc. The structure and significant elements need no repair. Calculations indicate the trusses are capable of supporting a total load of 135 psf (see figure B-9, sheet 10.11). According to the park staff no snow load reduction, by shoveling or any other method, was performed at this building and the resulting total load capacity of 135 psf appears to be adequate.

Repointing of the stonework is recommended to prevent moisture penetration. See existing measured drawings (HABS) for documentary data.

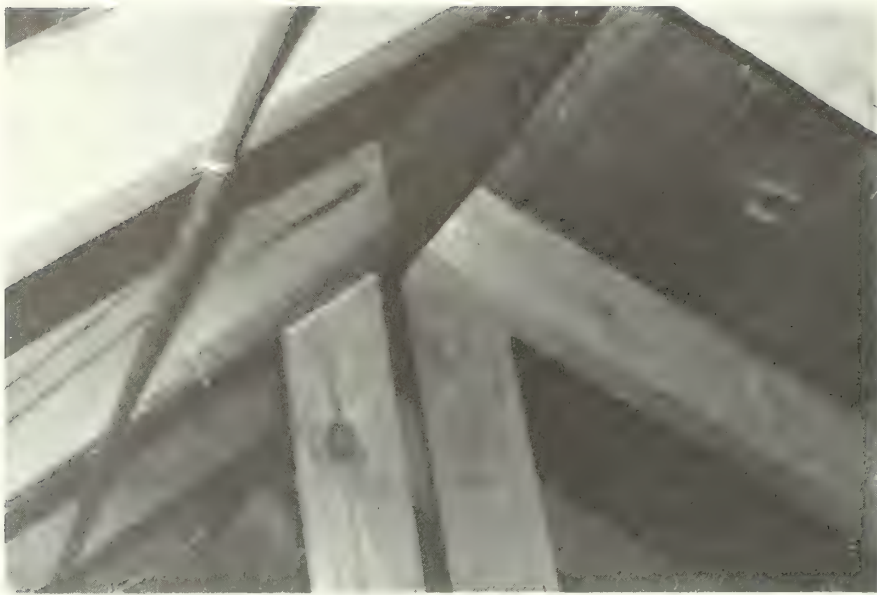
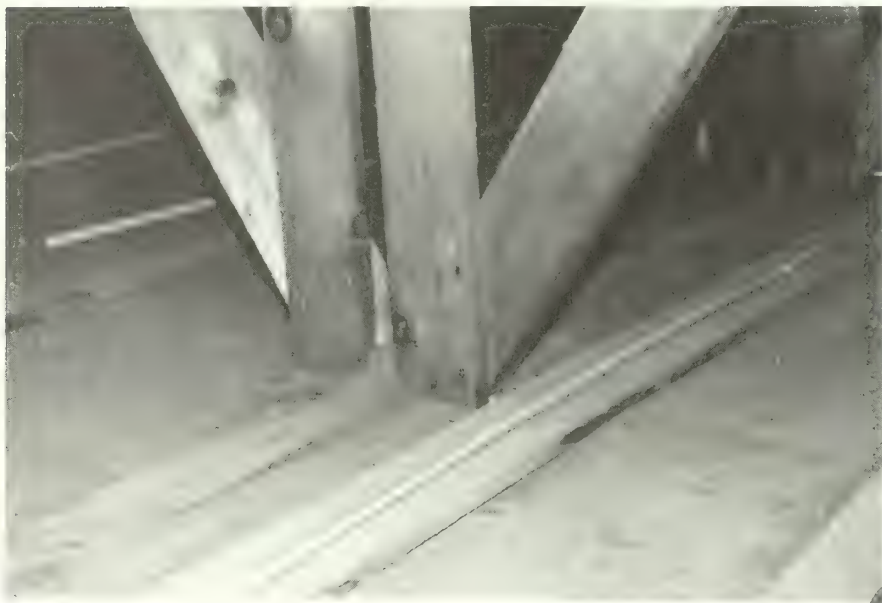
Figure B-4. Typical Market Building Roof Framing.

1. The roof system is under structured for a wood shake roofing system and would require snow shoveling unless it is reinforced.
2. When reroofing is undertaken, spot locations of water damaged rafters and sheathing should be replaced.

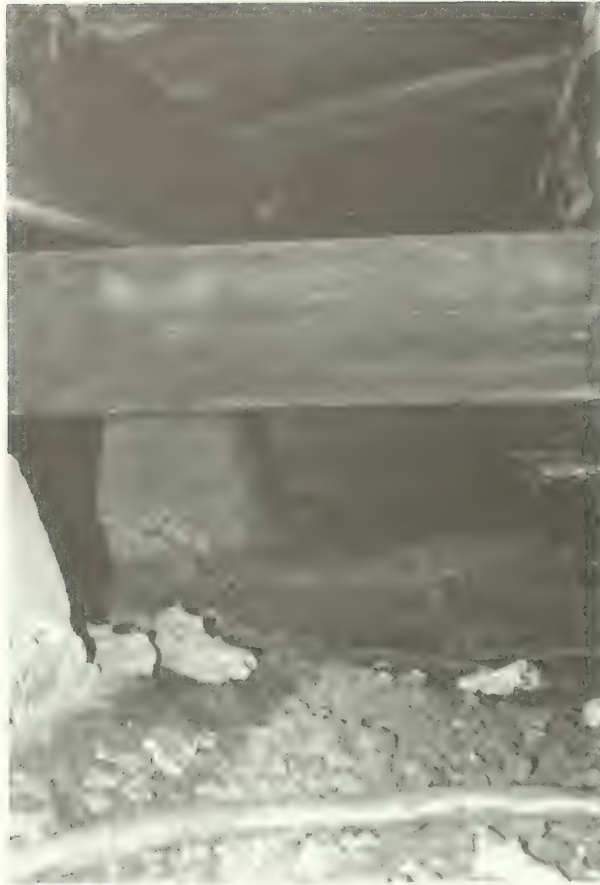
Figure B-8. Market building crawl space

3. Seismic-type connections are absent where the roof structural system joins the walls.
4. Excessive lateral earth pressure in conjunction with the negative site grading has deteriorated the rear foundation stem wall.
5. The concrete slab on grade in the rear of the building is deteriorated and cracked.
6. The timber framing at the southeast corner is rotten.
7. Floor and wall structural systems at the Fireside Lounge have extensive insect and moisture damage. The crawl space is inaccessible and has inadequate under-floor clearance and ventilation.

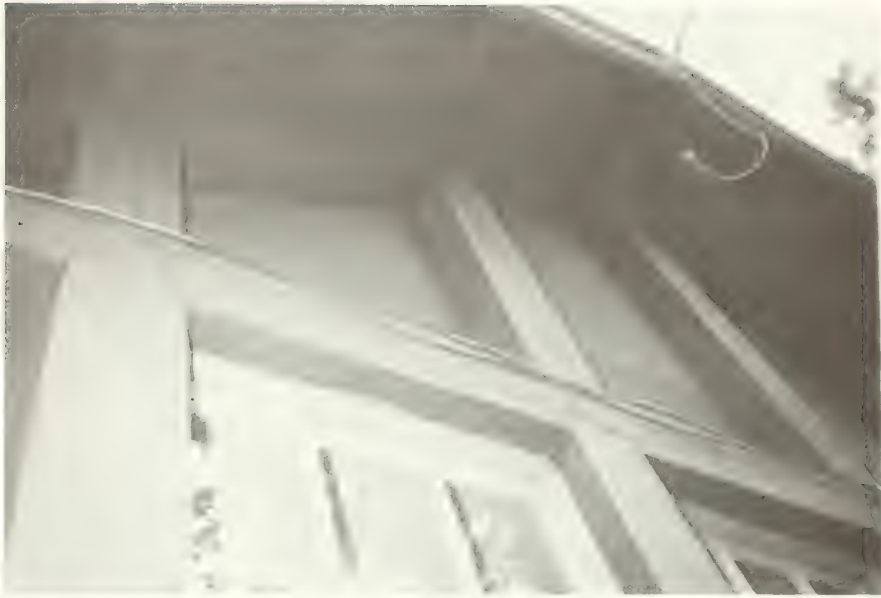
Figure C-1. Market, North Wing, West Facade (5/86). Exterior electrical wiring remaining from former light.

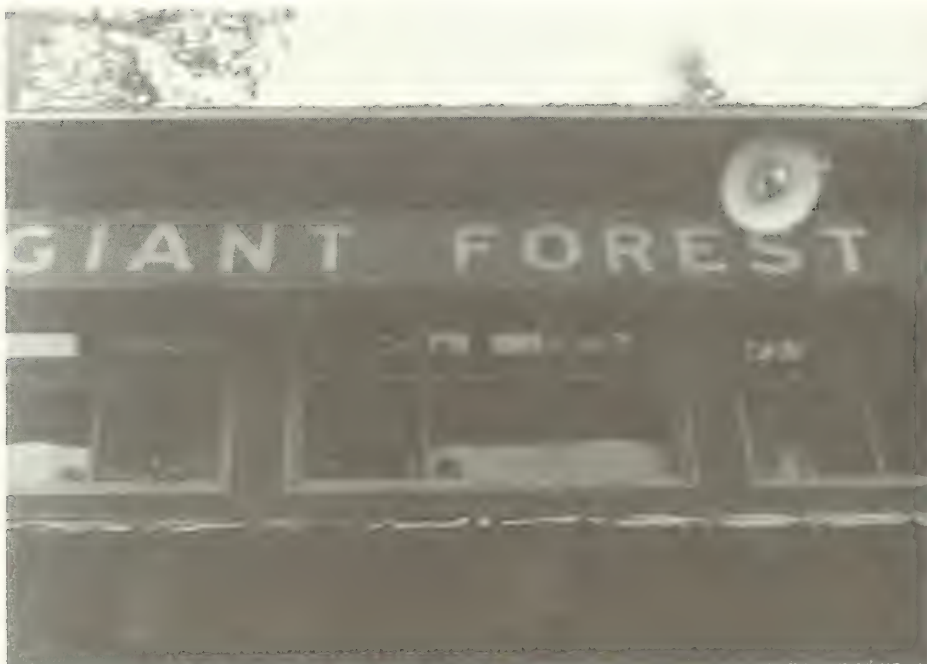
Figure C-2. Market Dormer (10/86). A second generation exterior light is located above the main entry under the dormer eave.

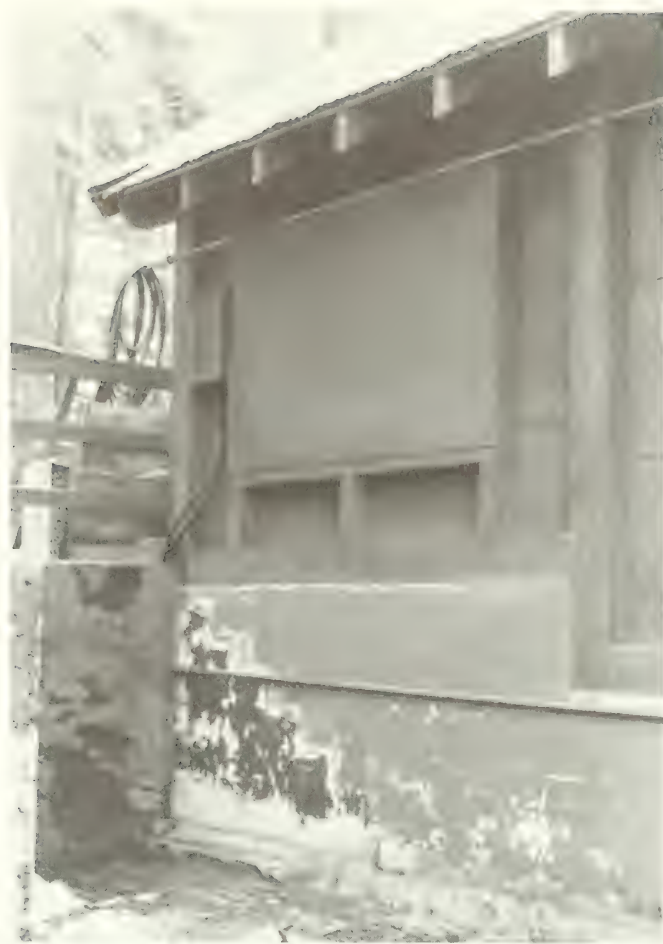
Figure C-3. Market Detail (10/86). The window fuse box is probably the original of 1938 electrification.

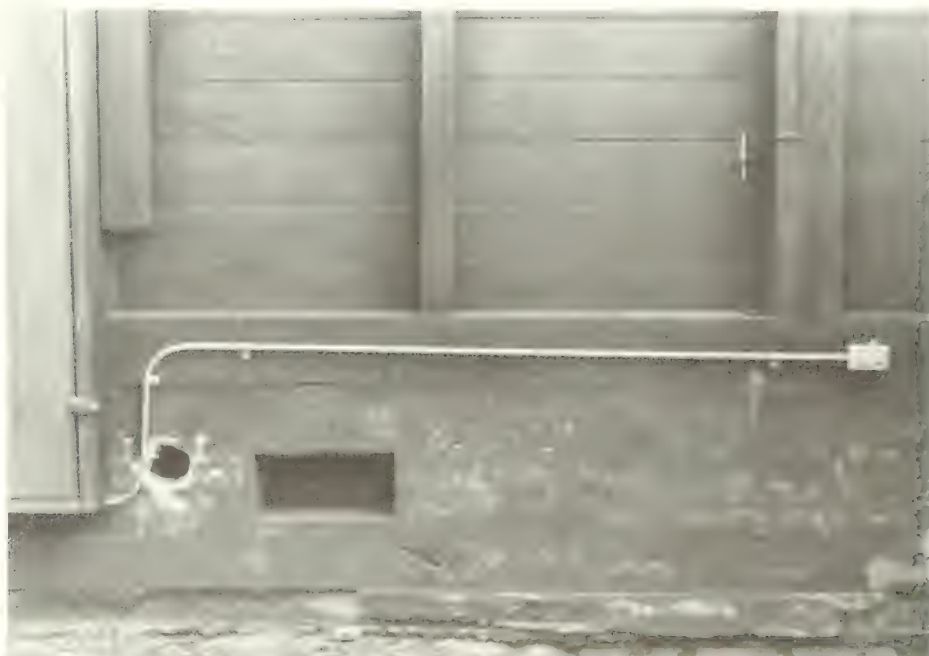
Figure C-4. Market Detail (10/86). Exterior mounted electrical conduit and A/C outlet on north facade.

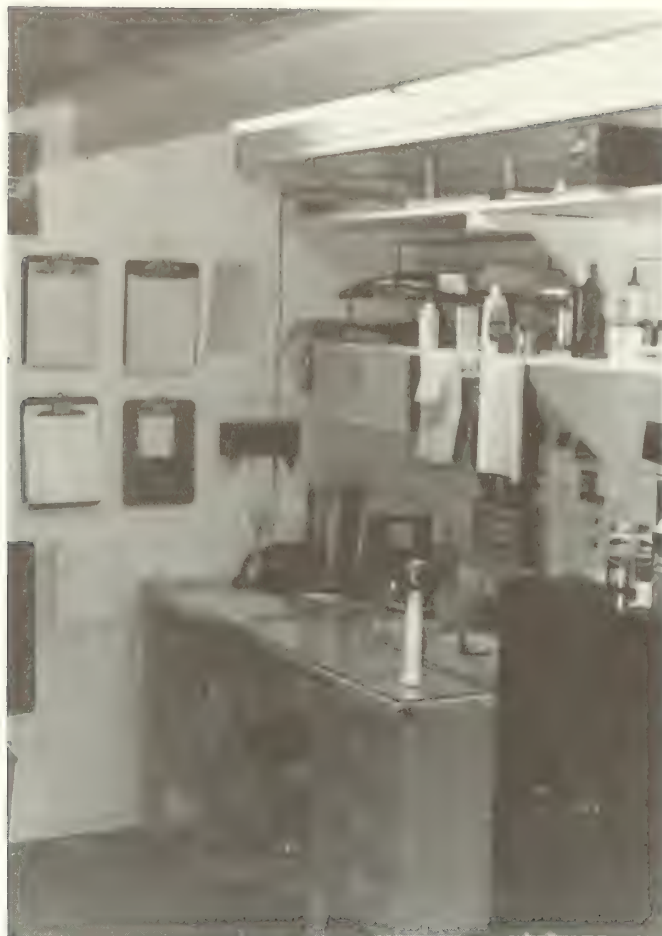
Figure C-5. Market, Manager's Office (5/86). The fluorescent fixture and surface mounted electrical conduit seen here were installed as part of the 1975 remodeling.

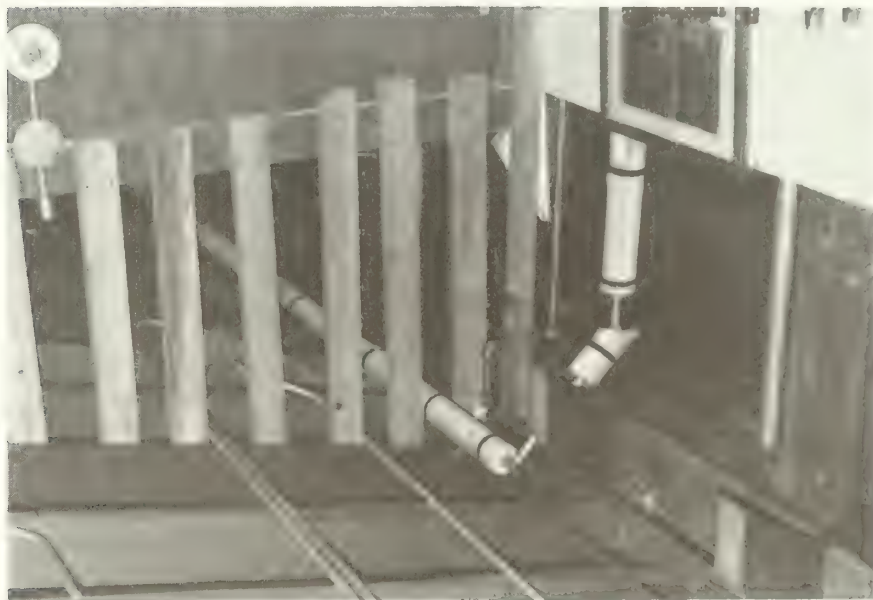
Figure C-6. Market Interior Detail (5/86). Joist mounted electrical conduit was installed in 1975. Note, insulation from waterline was tested for asbestos, see Appendix F.

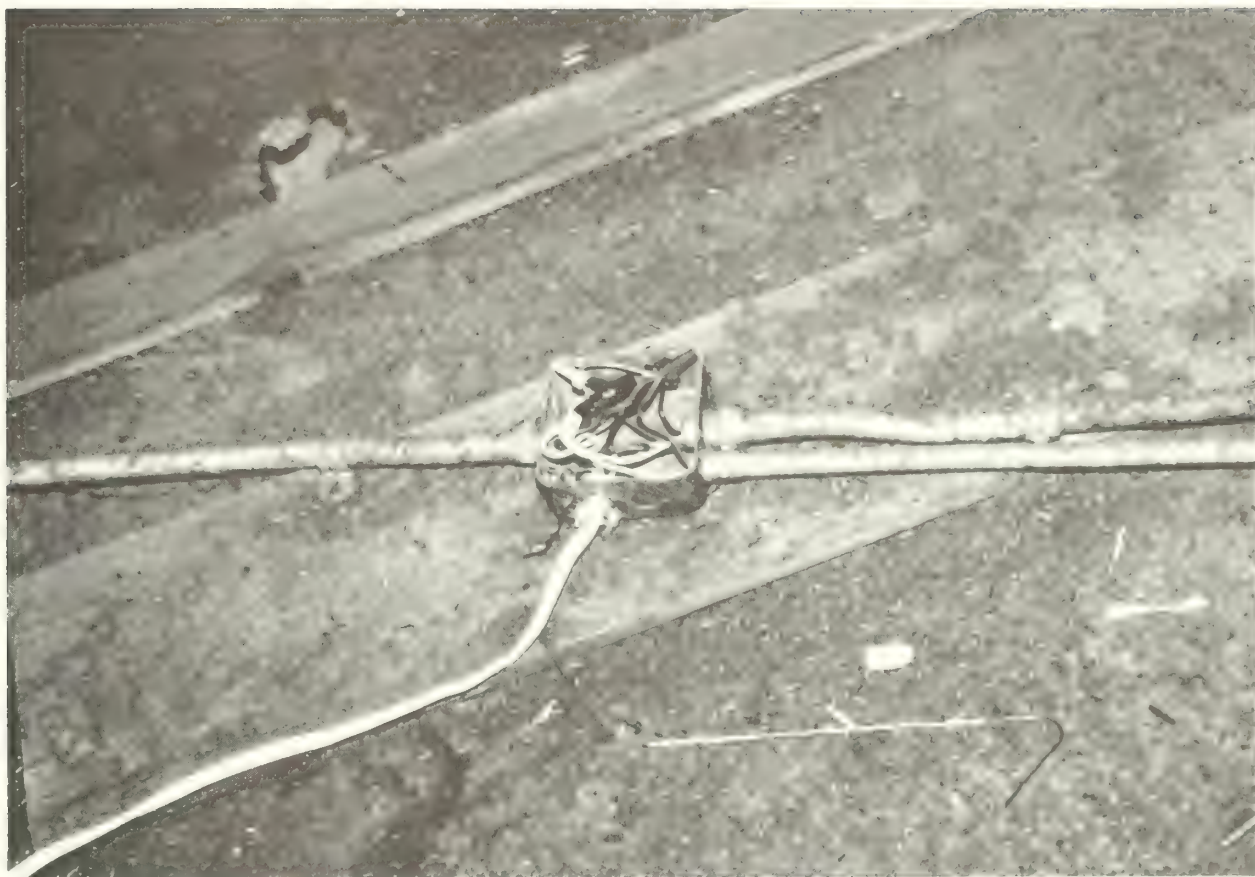
Figure C-7. Market Attic Detail (5/86). Close-up view of junction box and wiring, both in and out of conduit, as installed in the attic in 1975.

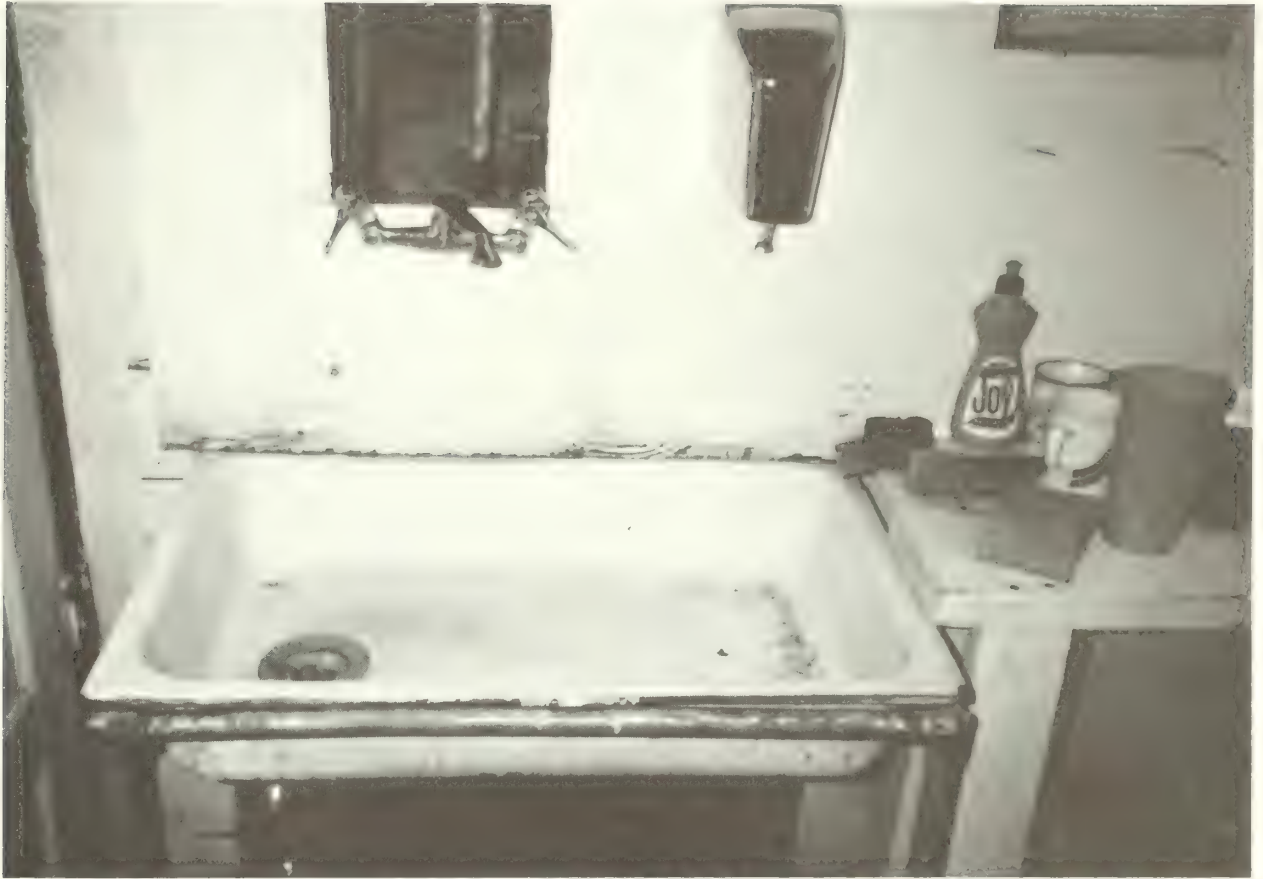
KGA-30-879, 36,000 BTUH (figure D-4). Currently it is the sole source of hot water in the market building and serves one employee sink in the market section (figure D-1), and one employee sink and a triple bar sink in the bar section of the building. It is adequate for present uses but should be replaced to serve intended loads at the time of the building rehabilitation. An electric model would likely replace this unit assuming the propane is removed. The water pipe is partly covered by old style insulation, which is in bad shape (figure C-6). A sample was collected and sent to a lab for detection of asbestos. Test results report is included in Appendix F.

Figure D-1. Market--employee wash sink (5/86).

The market building is heated by three ceiling mounted propane-fired unit heaters. The plumbing system consists of three sinks and condensate waste from various coolers. The systems are adequate for current use, but should be replaced when the buildings undergo the rehabilitation planned.
